Road Safety Audit Belknap Street Fort Worth, TX

APRIL 29, 2022

Facilitated by: Amelia (Millie) Hayes, P.E., PTOE, RSP₂₁
FHWA Texas Division

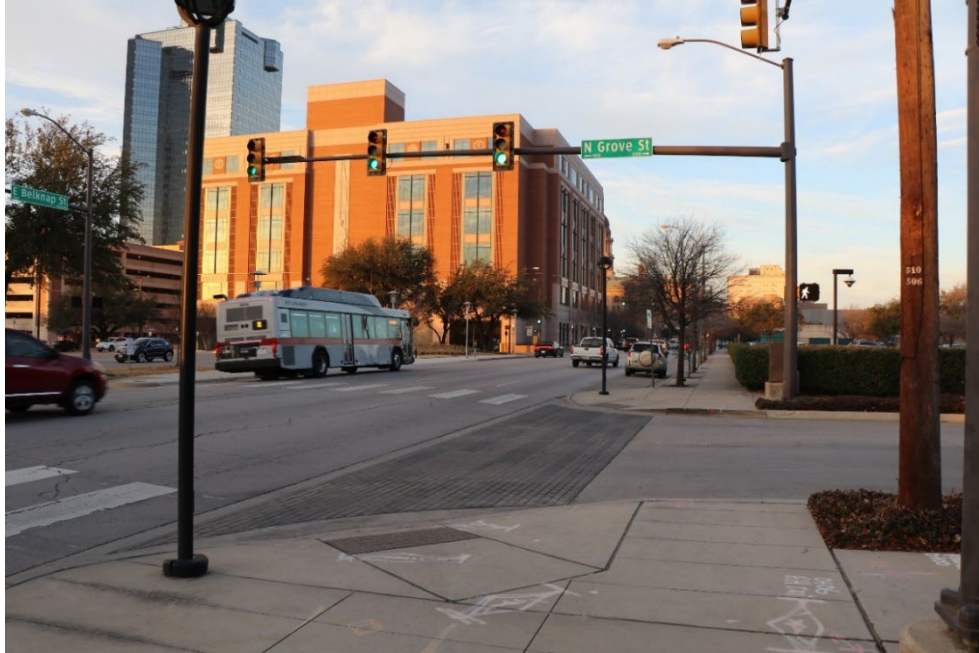
- **Observation:** At Grove and Pecan Streets, using ramps requires out-of-direction travel. The sidewalks in this area were away from the back of curb which improves pedestrian comfort; however, when combined with single ramp designed corners, the through path moves laterally up to 20 feet. This change in path can be particularly time consuming for wheelchair users with the many required changes of direction. Using dual-ramp corner designs is preferred for accessibility and allows for the ramps to line up more directly with the sidewalk path away from the corner. **Recommendation:** As discussed in the General Recommendations above, improve the consistency and directness of the walking path.

Figure 4: Sidewalks and crosswalk ramps require out of direction travel for some users

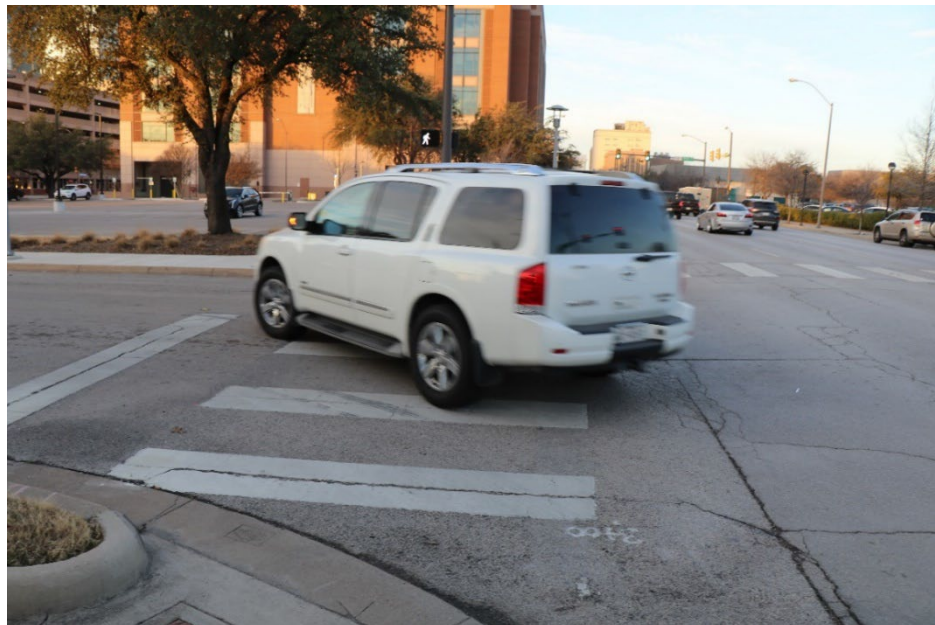
- **Observation:** At Grove and Pecan Streets, vehicle speeds were high for those turning left from Belknap onto Grove or Pecan. **Recommendation:** Consider hardened centerlines to slow vehicles turning left onto Pecan and Grove Streets, and possibly other locations. Hardening refers to the use of modular curbs, vertical delineators, and/or striping at intersections to reduce left-turning speeds and to prevent “corner cutting.” Timeline: Short-term.

Figure 5: Driver turning south onto Grove Street

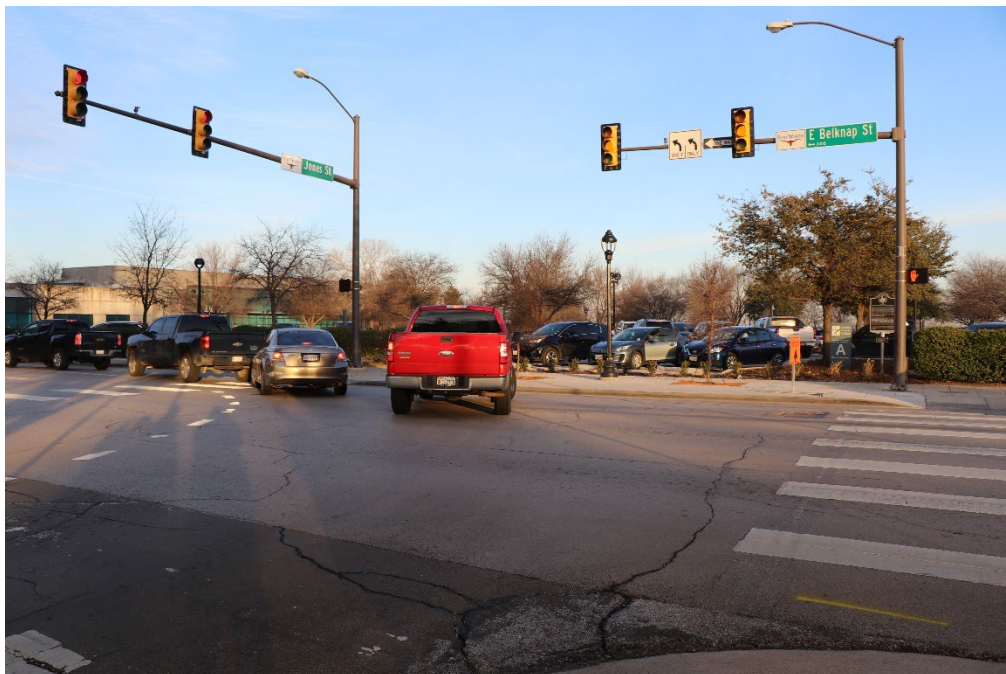
- **Observation:** At Jones Street, the rightmost left turn lane became blocked by the extended queue of vehicles waiting to turn right onto Commerce.
Recommendation: The City should investigate and verify whether there is a queueing issue from Commerce Street and extending onto Jones Street. If so, the City could consider signal adjustments or Do Not Block Intersection signs or pavement markings (per Texas MUTCD Section 3B.17). The City could also consider lane assignment guide signs on Jones (e.g. Right Lane to Commerce and Left Lane to West Belknap). Timeline: Short-term.

Figure 8: Extended queue of vehicles waiting to turn right onto Commerce Street

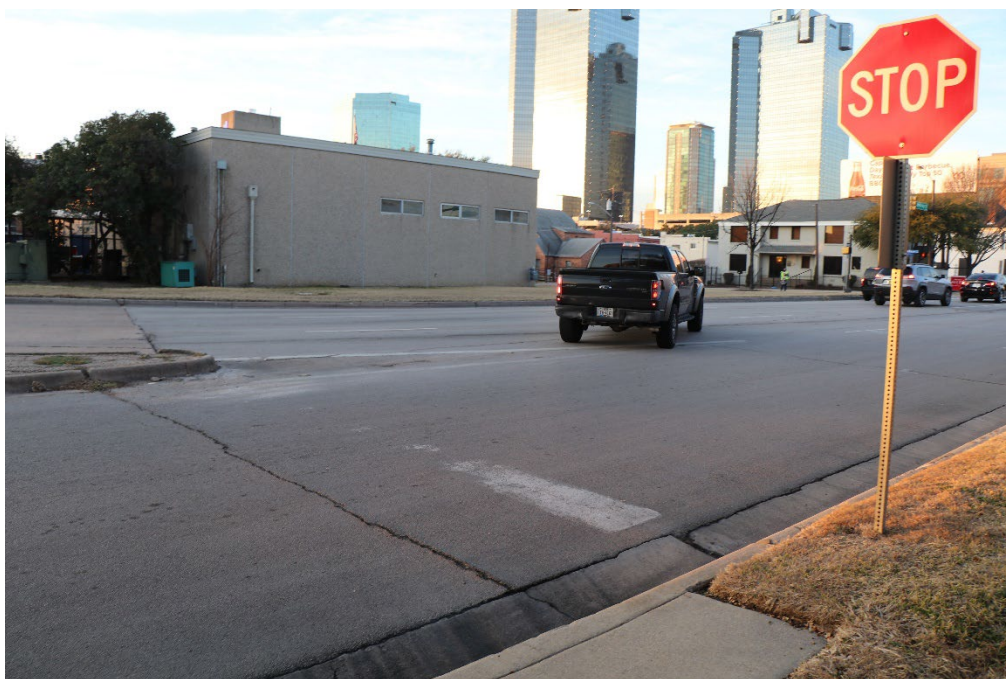
- **Observation:** Just east of our RSA limits, from the Weatherford/Belknap turnaround near Samuels Avenue, there is a prohibition of vehicles making a left turn onto Pecan Street. Many drivers were observed making the left turn movement from the Belknap turnaround onto Pecan Street, despite the prohibition. **Recommendation:** The City should investigate and verify. If this is an issue occurring regularly, the City could consider adding flexible vertical delineators. The City could also add a double white line to correspond with the Do Not Cross Double White Line sign (Texas MUTCD R4-3bT) already installed at the location. Timeline: Short-term.

Figure 9: The City should verify whether drivers are routinely completing prohibited turn; if so, consider adding flexible vertical delineators and/or double white line to correspond with existing R4-3bT sign

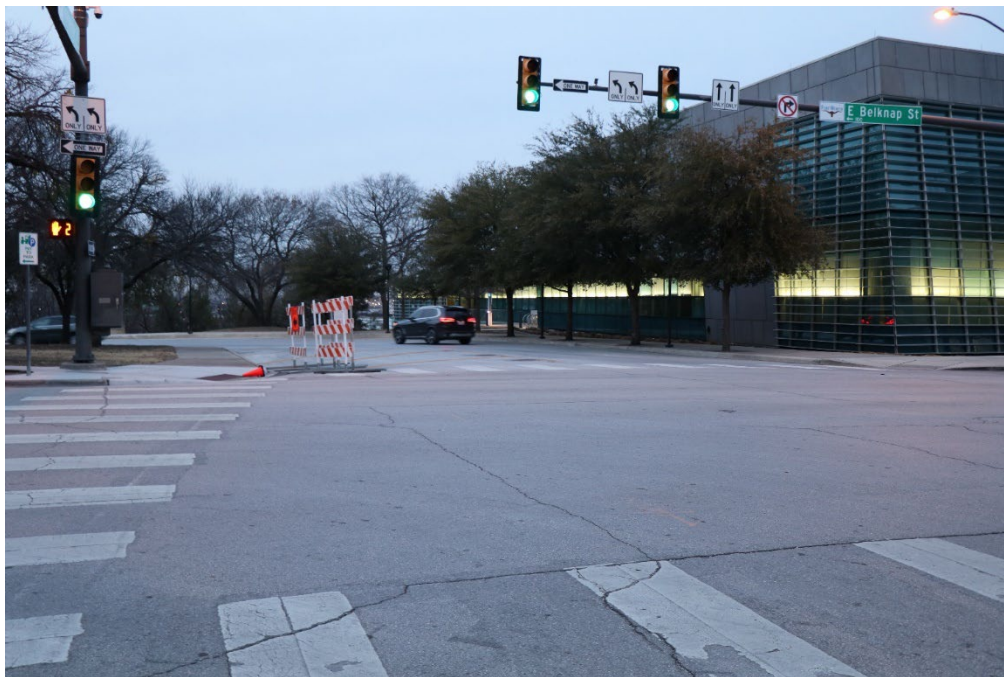
- **Observation:** At Commerce, a dual left turn lane was underutilized during our field review. The RSA Team’s review of Crash Reports showed two separate instances of pedestrian crashes that had occurred on the west side of the intersection, with both pedestrians traveling southbound on Commerce Street in early- to mid-afternoon (daylight conditions). **Recommendation:** Evaluate vehicular traffic levels versus pedestrian demand for the dual left turn lanes from Commerce Street onto Belknap Street. Dual turn lanes typically show less yielding to pedestrians by drivers. This location should also be considered for Flashing Yellow Arrow for pedestrian conflicts as discussed in General Recommendations, above. Timeline: Short- to medium-term.

Figure 10: Dual left turn lane at Commerce Street

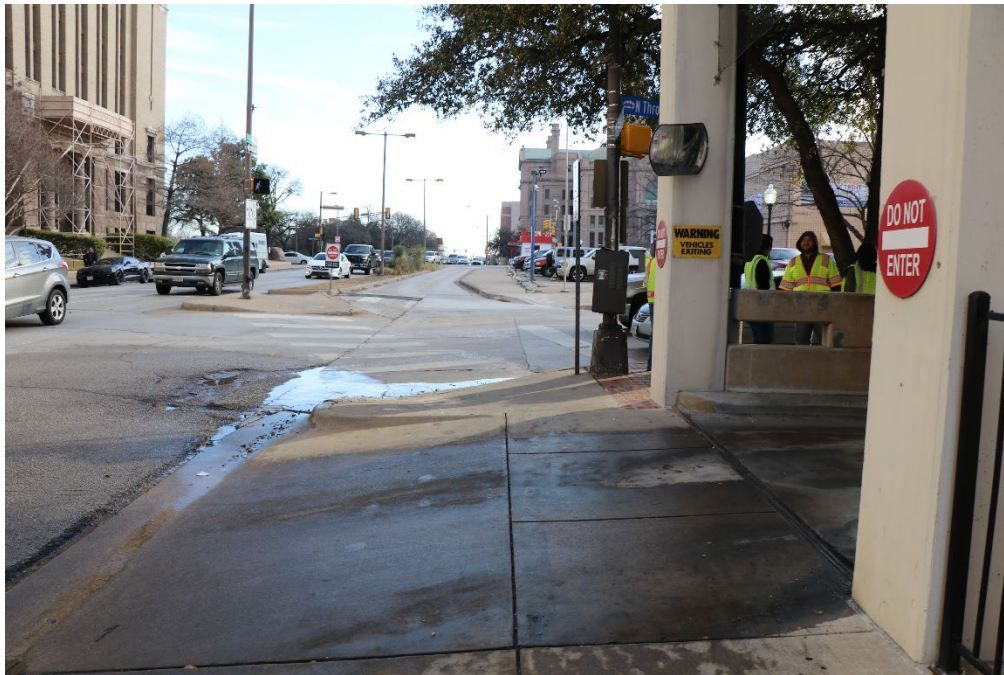
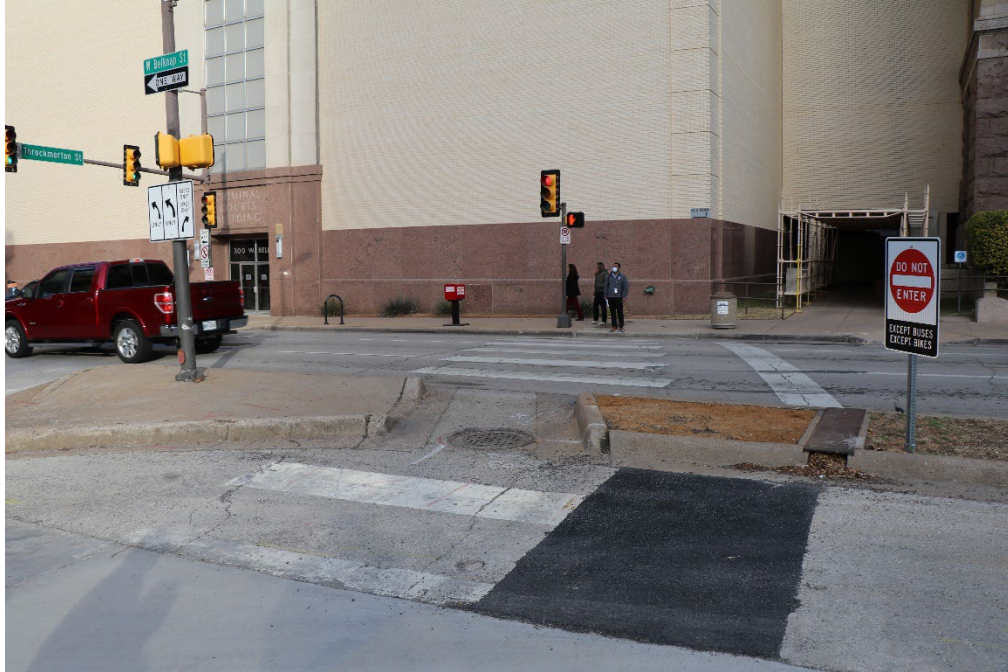
- **Observation:** At Throckmorton Street, there were misaligned crosswalks and ramps, particularly on the east and south sides of the intersection. The marked crosswalks at the intersection are not well aligned with desired walking paths, including a change in direction on one leg while crossing the median (bus/bicycle turnaround on the block between Commerce and Throckmorton Streets).

Marked crosswalks do not align with curb cuts, and one curb cut was provided for the west side of the intersection but signed as No Pedestrian Crossing. The south side of the intersection has a large amount of ambiguous space where the crosswalk exists well away from the curb cut and desired walking path. The RSA Team observed multiple instances of pedestrians crossing outside of the crosswalk on the south side of the intersection, including some near-miss crashes. Future developments with the Tarrant County project may include removal of the bus/bicycle turnaround (which is not currently used by Trinity Metro), which could provide an opportunity to consider intersection improvements and realignment. **Recommendation:** Improve the directness of the walking path. Marked crosswalks should be provided straight across the shortest path from corner to corner, and dual ramp curb ramps designs should be provided where applicable. Timeline: Short-term to coordinate with Tarrant County project on bus/bicycle turnaround within their upcoming project, otherwise medium- to long-term.

Figure 11: Misaligned crosswalks and ramps at Throckmorton Street, with bus/bicycle turnaround

Figure 12: Misaligned crosswalks and ramps at Throckmorton Street

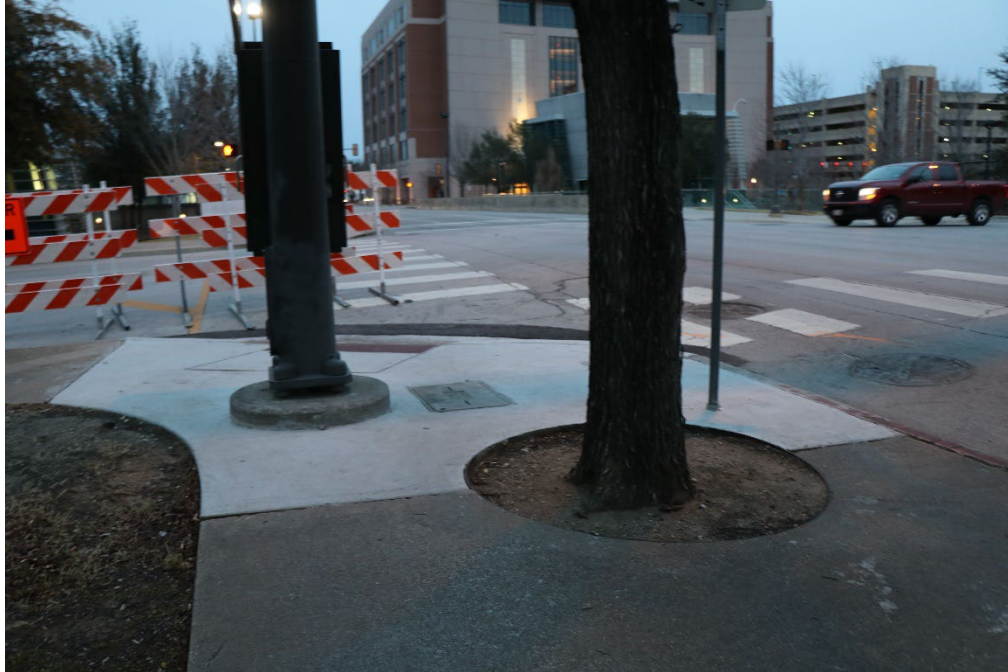
- **Observation:** Sidewalk was obstructed in some locations, including the northwest side of the intersection at Commerce Street. **Recommendation:** As discussed in the General Recommendations above, improve the consistency and directness of the walking path. Sidewalks should be a minimum of six feet wide, free of obstructions, with wider areas when needed. Ensure removal of temporary traffic control devices when no longer in use. Timeline: Short-term to coordinate with Tarrant County project on possible corrections within their upcoming project, otherwise medium- to long-term.

Figure 13: Obstructed sidewalks at Commerce Street

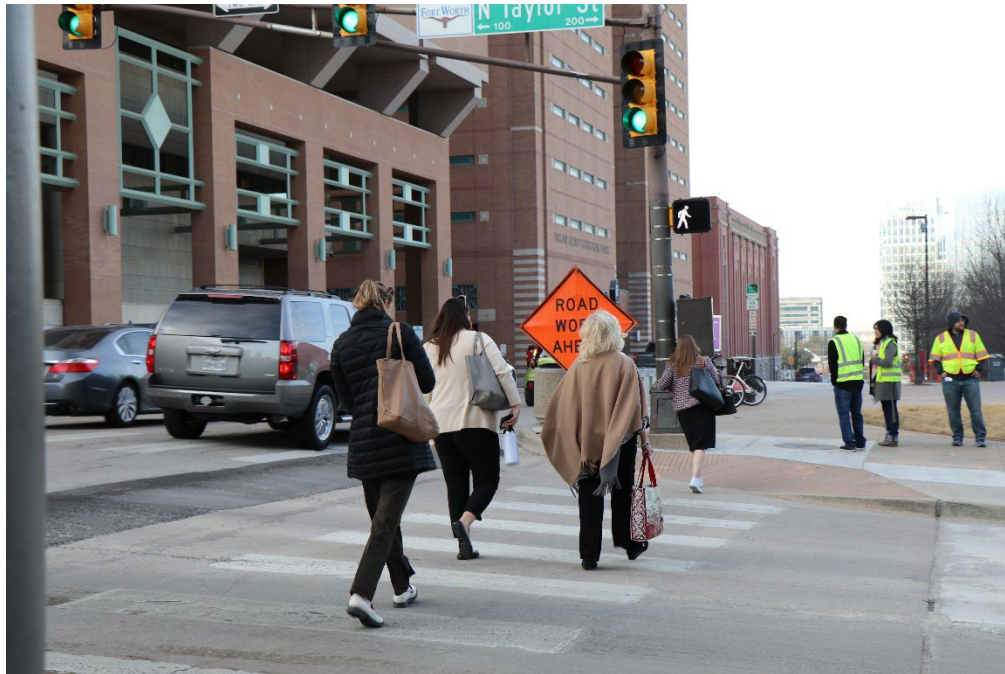
Figure 14: Steady flow of pedestrians during every signal cycle at Taylor Street

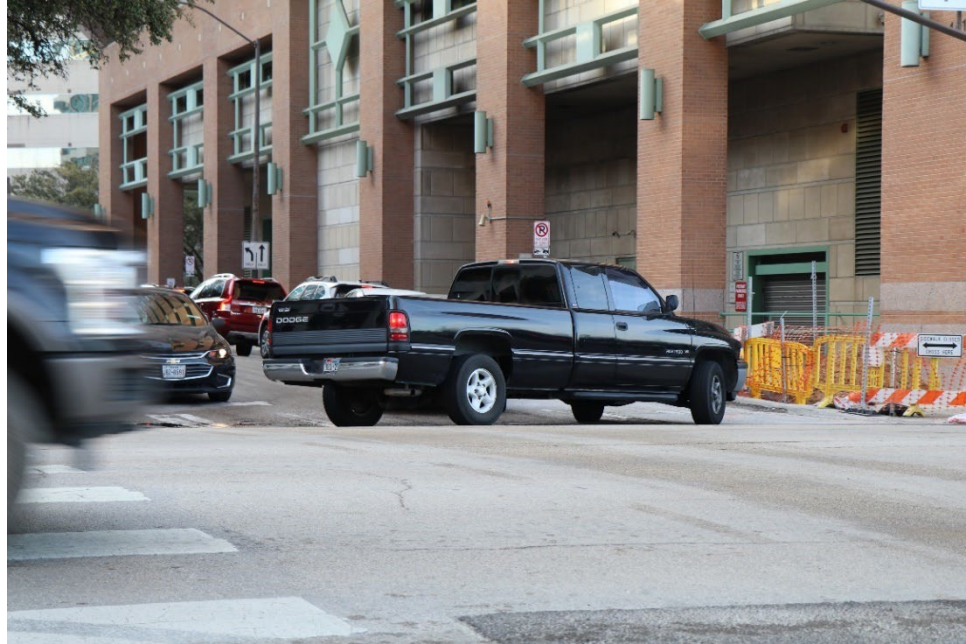
- **Observation:** At Taylor Street, vehicle traffic queued from Weatherford/Taylor onto Belknap/Taylor. During the morning peak period, queueing vehicles extended into the intersection, resulting in conflicts with pedestrians crossing Taylor Street to enter the Tim Curry Criminal Justice Center. **Recommendation:** The City should investigate and verify the presence of consistent queueing and intersection blocking on other days and time periods. If so, the City could consider signal adjustments or Do Not Block Intersection signs or pavement markings (per Texas MUTCD Section 3B.17). Timeline: Short- to medium-term.

Figure 15: Queuing from Weatherford/ Taylor onto Belknap/Taylor

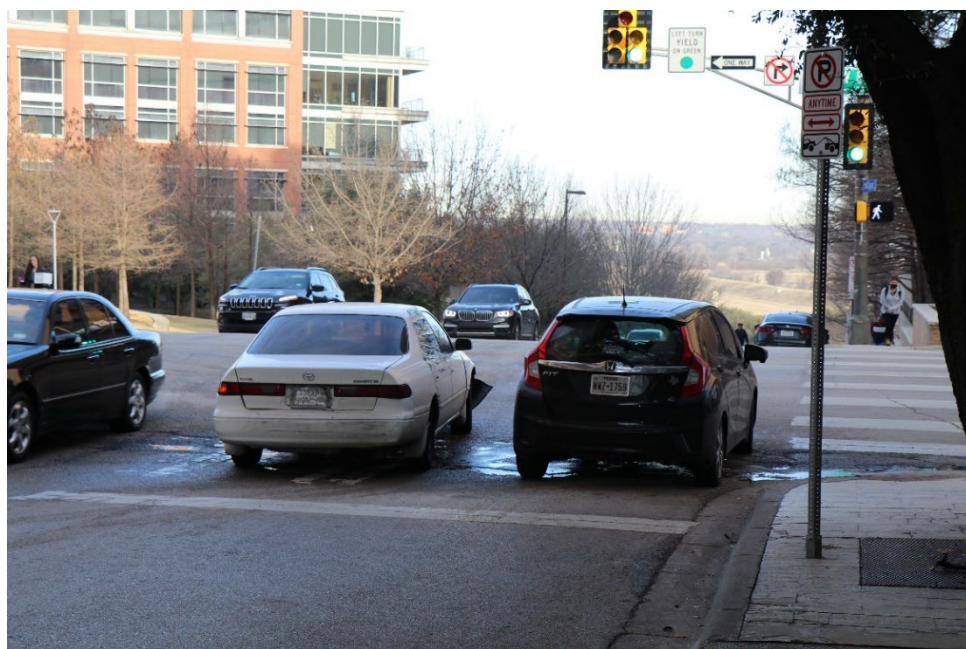
- **Observation:** For vehicles traveling northbound at Taylor Street, the single lane is wide enough to be ambiguous. Drivers traveling through the intersection tended to cut around drivers turning left onto Belknap while they waited for a gap in traffic. Recommendation: For northbound Taylor traffic, the City could investigate further signal timing adjustments or pavement marking improvements (e.g. reduction of receiving lane width and/or addition of left-turn pocket). Timeline: Short- to medium-term.

Figure 16: Driver at right passing in what is marked as single lane, creating additional potential conflicts at Taylor Street

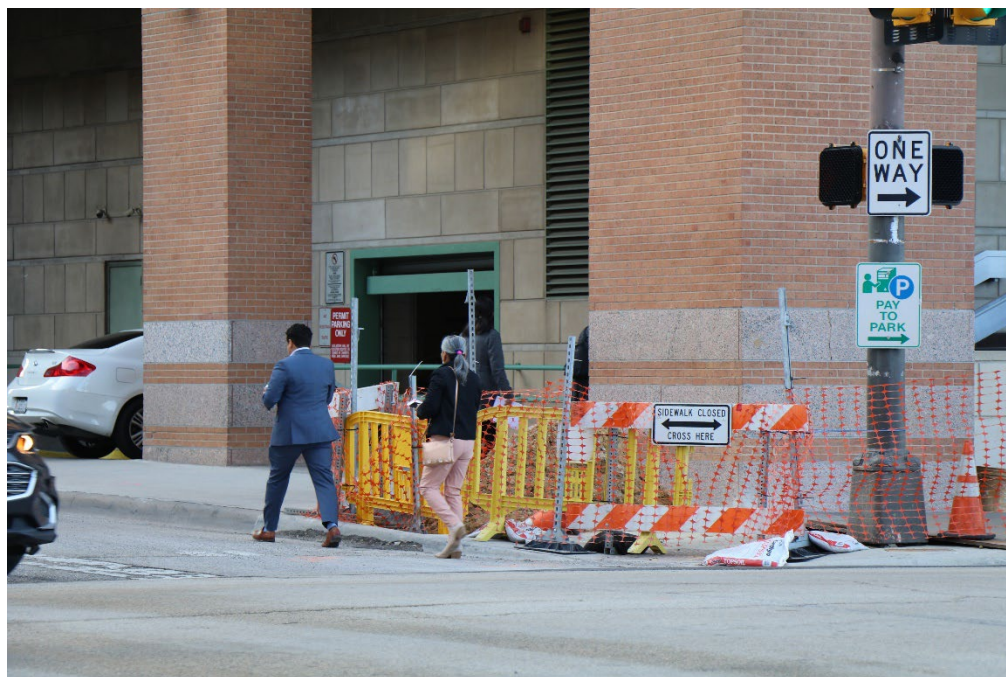
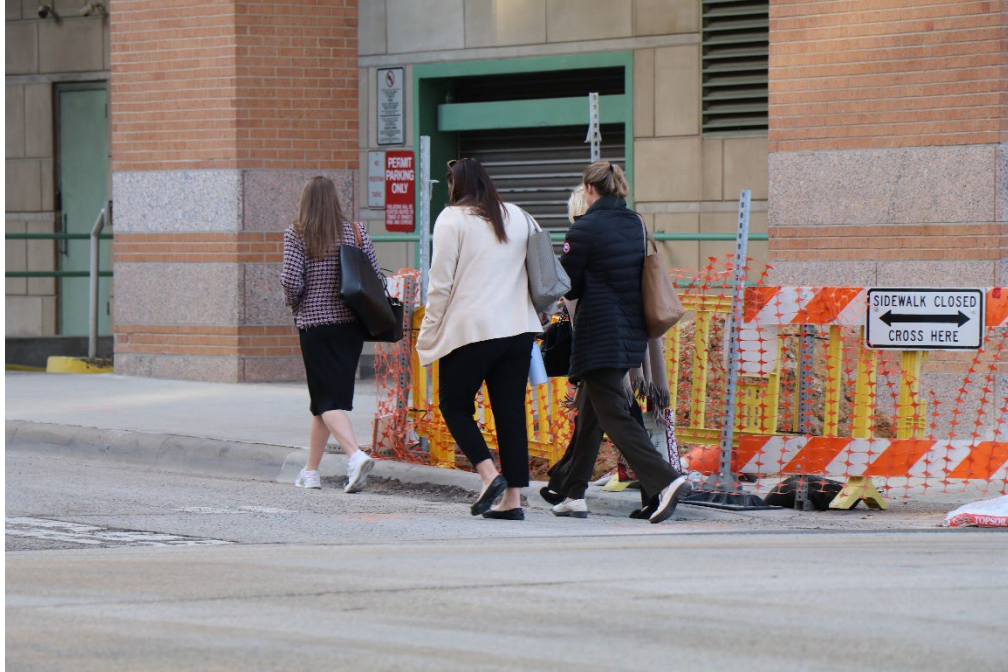
- **Observation:** At Taylor Street, there is a sidewalk closure on the southwest side of the intersection (adjacent to the Tim Curry Criminal Justice Center) due to a construction closure. The area currently under construction does not have a continuous walking path and results in pedestrians walking into the parking lane and travel lanes, and is inaccessible to someone in a wheelchair. The sidewalk closure has no advanced warning signs. Due to the high pedestrian traffic in the morning peak hours, the pedestrians were often observed walking two abreast in the roadway. **Recommendation:** The City should investigate who is responsible for the construction work at this location. The City should have standards for accessible detour paths for sidewalk closures. Sidewalk closures should be at least as accessible as they were prior to construction. **Timeline:** Short-term to provide continuous and accessible walking path, and medium-term for updating City standards for sidewalk closures.

Figure 17: Pedestrians navigating sidewalk closure at Taylor Street

Figure 18: Pedestrians navigating sidewalk closure at Taylor Street

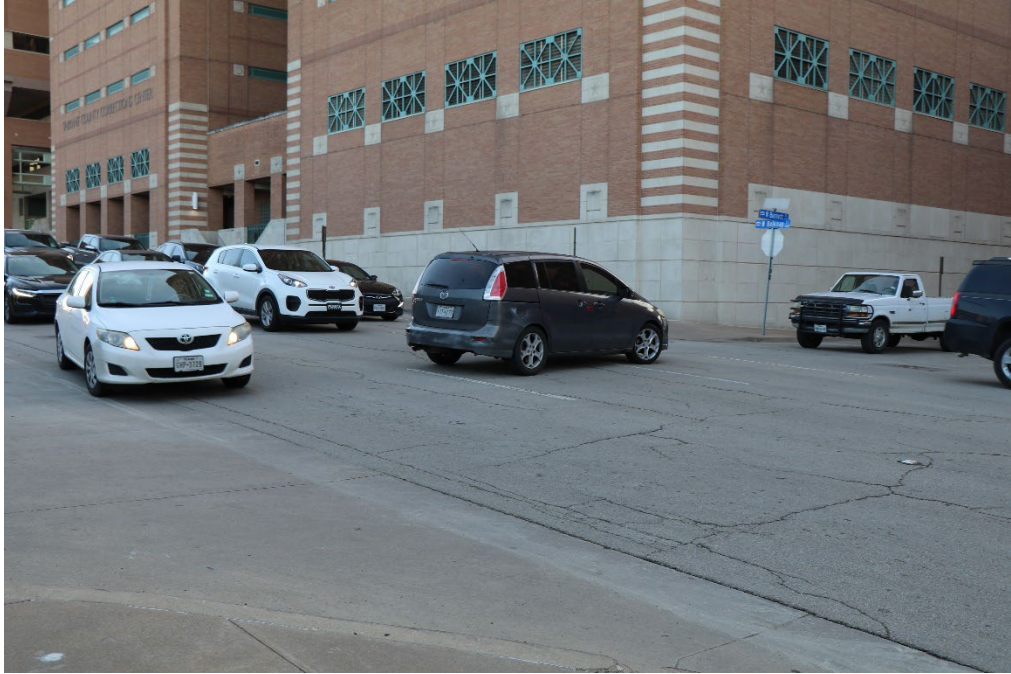
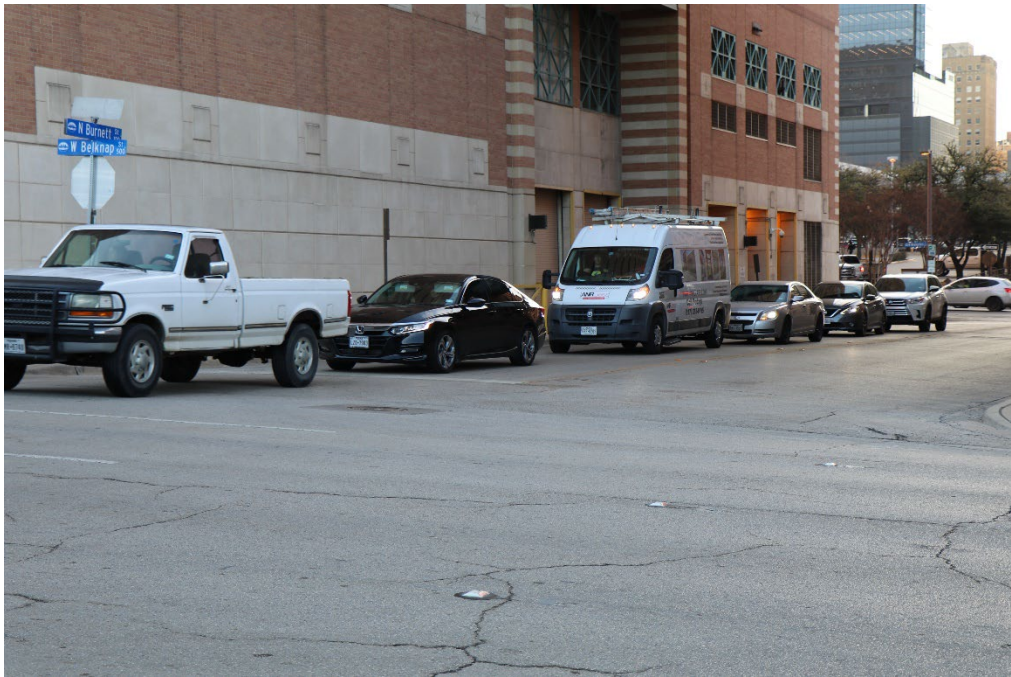
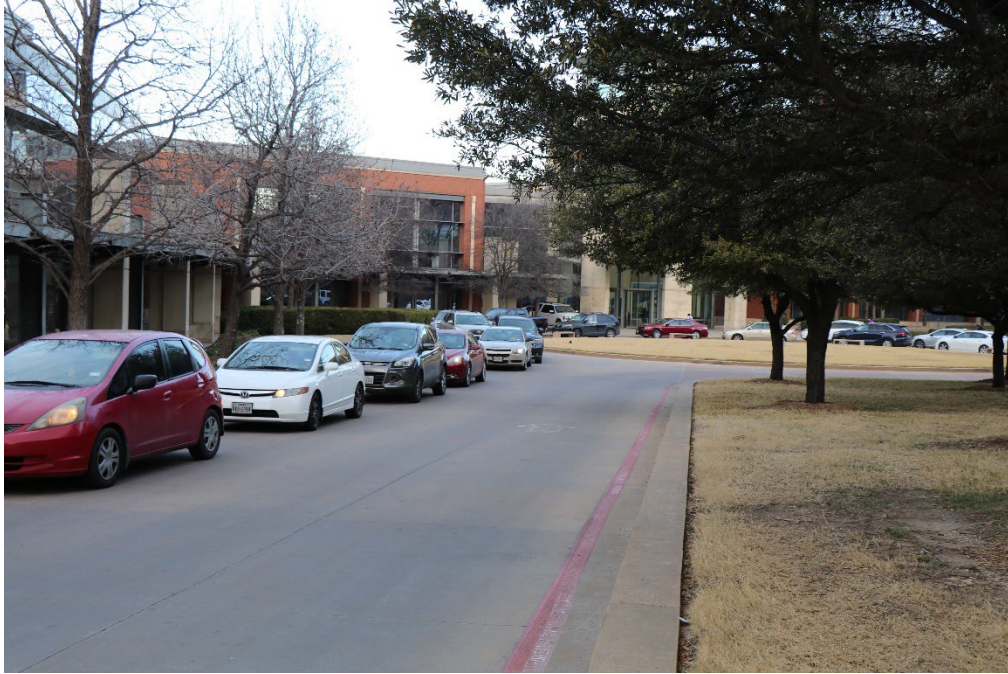
- **Observation:** The progression of vehicles on Belknap Street, and vehicles turning onto Belknap from Lamar and Taylor Streets, provides continuous vehicular traffic on Belknap Street. This provides few gaps in traffic at Burnett Street, which causes delays at the TCC circle at dropoff and pickup times. Queues of northbound vehicles were observed at Burnett Street, most of which were waiting to cross into the circle, as well as long queues to exit the circle, often resulting in risky maneuvers and near-misses. **Recommendation:** Consider adding a traffic signal at Burnett Street at Belknap Street, and possibly Burnett Street at Weatherford Street. **Timeline:** Short- to medium-term to study whether signals are warranted at this location, and medium- to long-term to install if warranted.

Figure 19: Drivers completing risky maneuvers at Burnett Street

Figure 20: Northbound queue at Burnett Street

Figure 21: Southbound queue at Burnett Street, exiting TCC circle after completing student drop-off

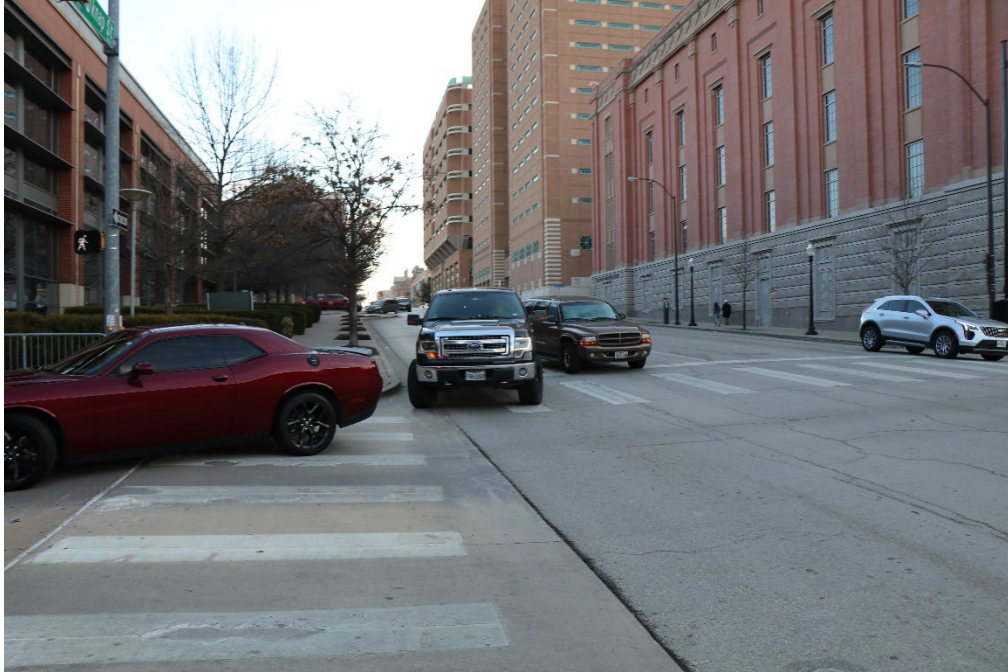
- **Observation:** There were many vehicular conflicts around the Cherry garage entrance. In both morning and evening peak hours, the RSA Team observed drivers entering the added right lane just before Cherry Street, only to weave back into the second lane to try to get around the vehicles slowing to turn right into the Cherry Street garage, then ultimately merging into the right lane again to turn right onto North Henderson Street. Additionally, due to the constant vehicle traffic, few gaps in traffic, and uncertainty of whether drivers are turning onto Cherry Street or North Henderson Street, it was sometimes difficult for people walking to cross the Cherry Street garage entrance in this location at both morning and evening peak hours. **Recommendation:** Consider a dedicated right turn lane into the Cherry Street garage. As discussed in the General Recommendations section, dedicated right turn lanes could help reduce conflicts by eliminating weaving maneuvers into an area where most drivers will be turning. A right turn lane into the Cherry Street garage could be tested on a temporary trial basis by installing signage and temporary pavement markings, and flexible vertical delineators on the far end of the intersection to prevent through traffic. Timeline: Short-term for trial, and medium- to long-term for any permanent changes.

Figure 22: Vehicular conflicts at Cherry Street garage (note the weaving vehicle behind the turning vehicles entering TCC parking garage)

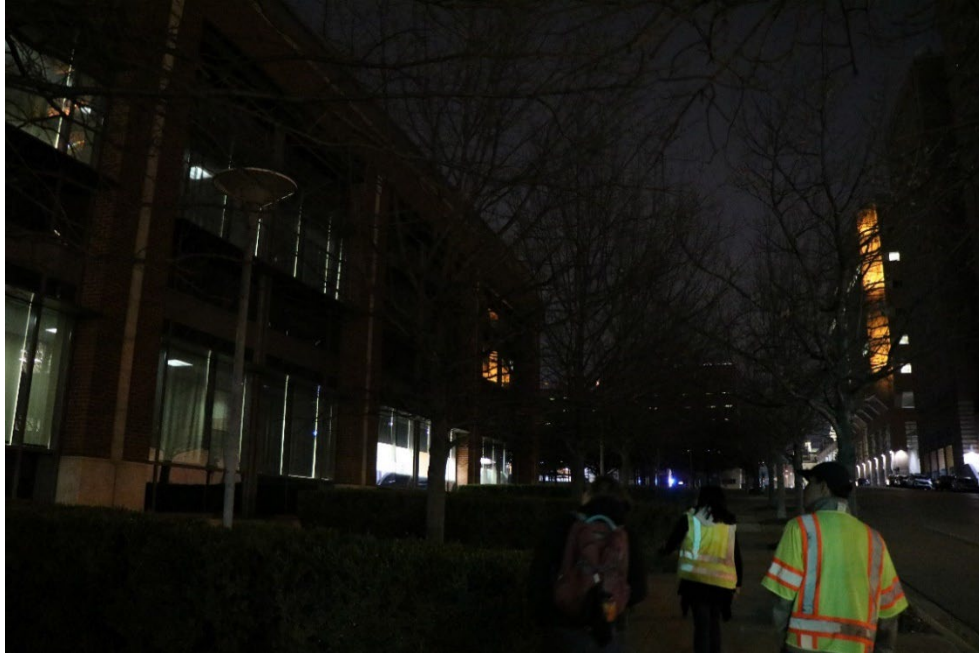
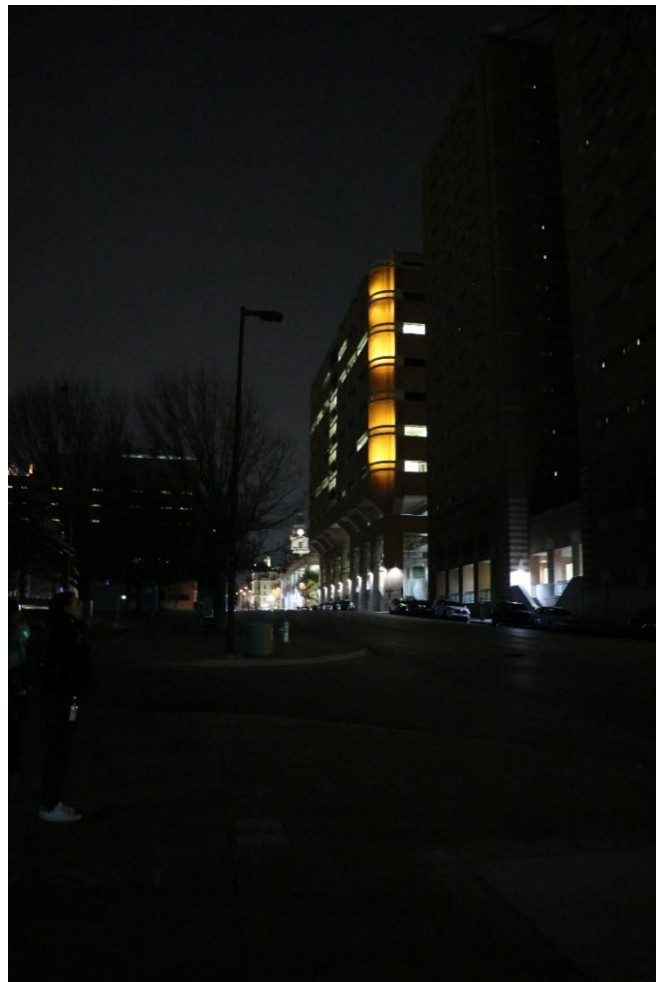
- **Observation:** Lighting near Tarrant County College – Trinity River Campus was not operational. While there were City street luminaires (on the north side of Belknap) and pedestrian-scale and landscape (tree well) lighting installed in this location, lighting was not operational during the night review. Lights in the new Trinity Metro bus shelter (Belknap at Burnett, route 046) were also not operational. With the lights not being operational at the time of observation, the RSA Team cannot comment on the adequacy of the existing lighting in improving safety along this section. **Recommendation:** Determine the cause of lighting not being on, and correct to make lighting operational. Once operational, evaluate to ensure proper lighting is provided. Timeline: Short-term.

Figure 23: Non-operational pedestrian-scale lighting near TCC

Figure 24: Non-operational City street luminaires near TCC

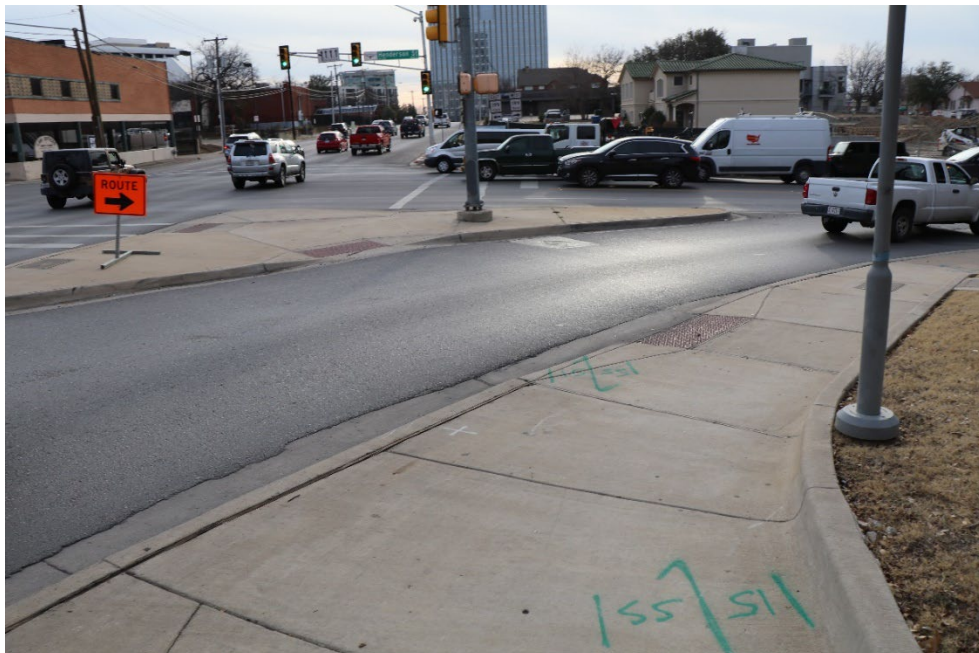
- **Observation:** The right turn movement from Belknap Street to North Henderson Street has no control (yield or stop signs, or pavement markings) or crosswalk pavement markings. Vehicle speeds were high for those turning right onto North Henderson since turning vehicles have their own lane until the Tarrant County College parking garage/Peach Street. **Recommendation:** Install yield sign and marked crosswalk. During future improvement projects, consider [TxDOT's new standard](#) for right turn islands, which tightens the right turn and provides improved visibility for crossing pedestrians. Timeline: Short-term for pavement markings, medium-term for right turn island.

Figure 25: Right turn island at Henderson
