Road Safety Audit Belknap Street Fort Worth, TX

APRIL 29, 2022

Facilitated by: Amelia (Millie) Hayes, P.E., PTOE, RSP₂₁
FHWA Texas Division

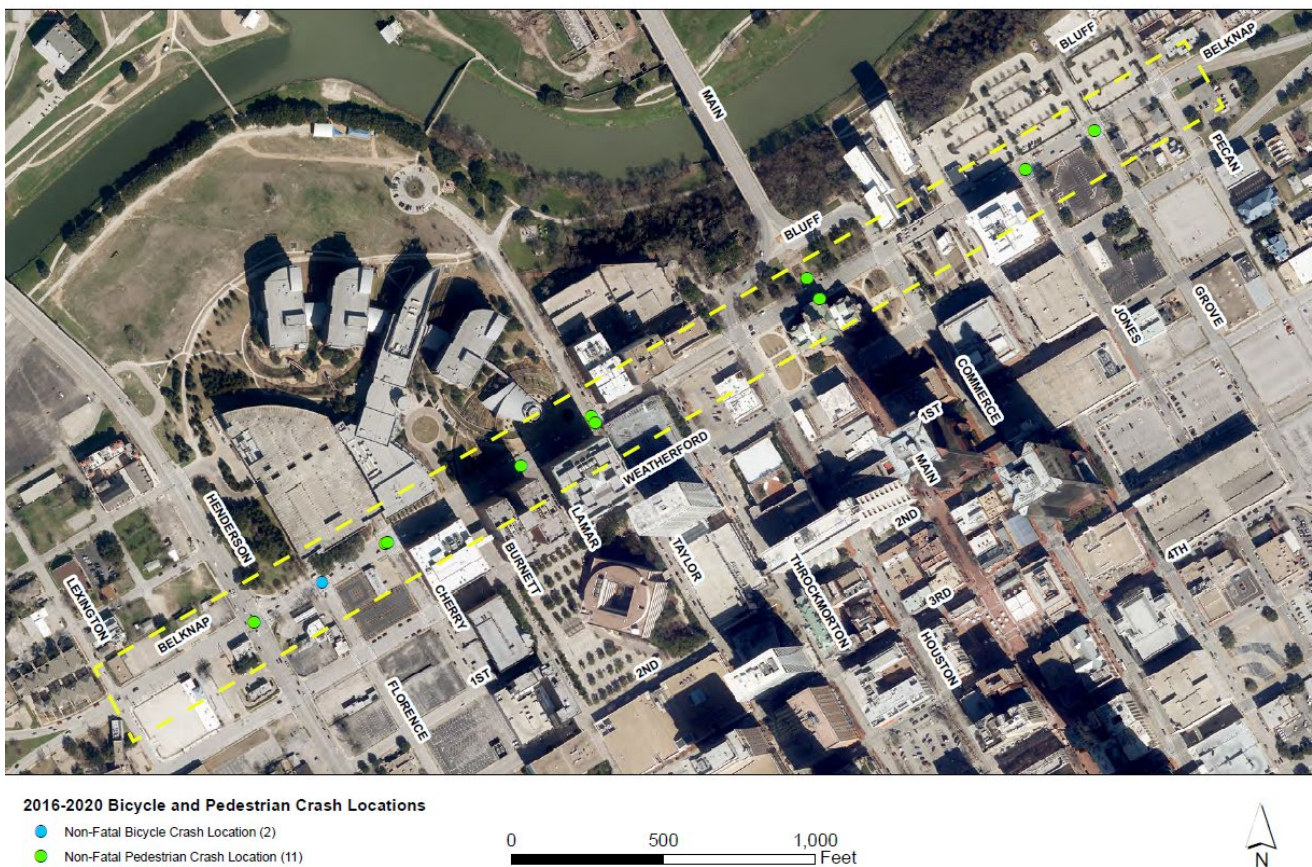
Figure 2: Pedestrian and Bicyclist crash map of the Belknap corridor. (Source: NCTCOG)

As shown in the map above, pedestrian crashes are distributed evenly throughout the corridor and are primarily at intersections (note: the two pedestrian crashes that appear directly in front of the Courthouse on the map were actually within the crosswalk at Commerce Street). The RSA Team reviewed pedestrian and bicycle Crash Reports (TxDOT Form CR-3) for any trends in location or other similarities.

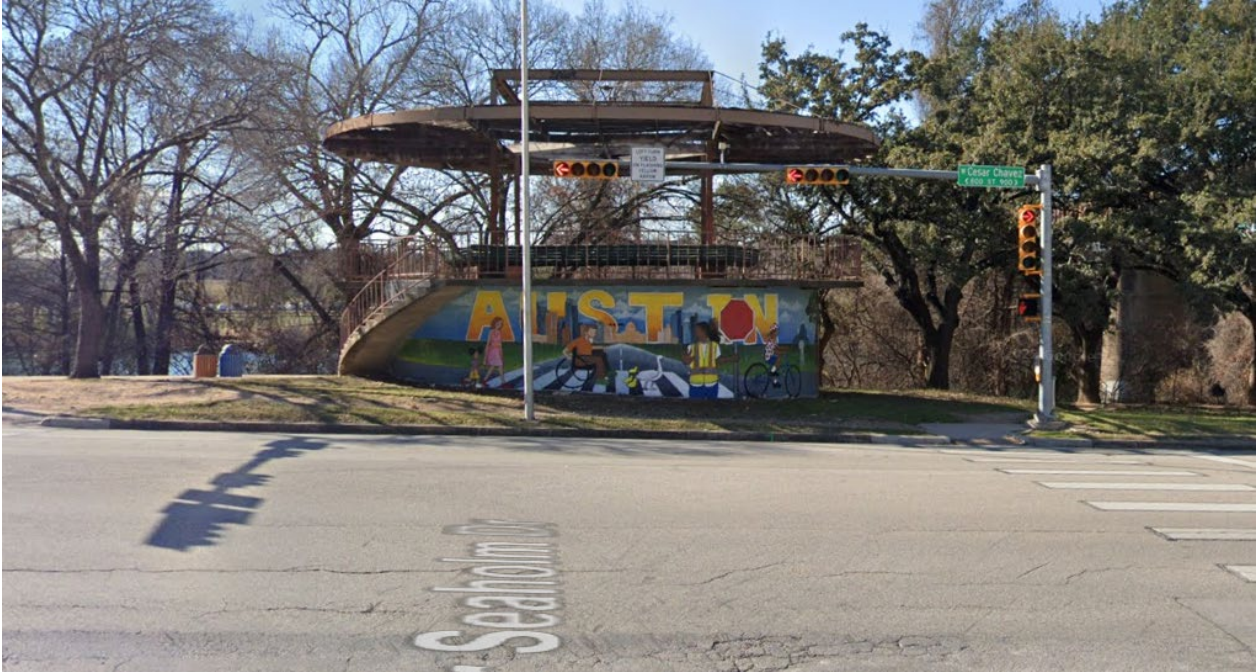
Figure 3: Example of Flashing Yellow Arrow for pedestrian conflicts (Google Street View)

- Manage conflicts between pedestrians and drivers. Consider implementing the emerging trend of using Flashing Yellow Arrow for pedestrian conflicts instead of circular green signal indication where possible. Some municipalities, including Austin and Houston, have been using the Flashing Yellow Arrow in areas with pedestrian conflicts. Research indicates that the Flashing Yellow Arrow increases yielding behavior and “fails safe” in that drivers stop when they are unsure what to do while with a circular green signal indication drivers tend to go when they are unsure what to do. Houston and Taylor Streets might be particular locations for further study. While the City is considering the Flashing Yellow Arrow, a more immediate temporary Turning Vehicles Yield to Pedestrians signs (R10-15L) and pavement marking extensions through intersections (“puppy tracks”) could be installed. Timeline: Timeline: For Flashing Yellow Arrow, short-term in some locations, medium- to long-term if new equipment is needed. For signage and pavement markings while the City considers and/or plans for Flashing Yellow Arrow, short-term.

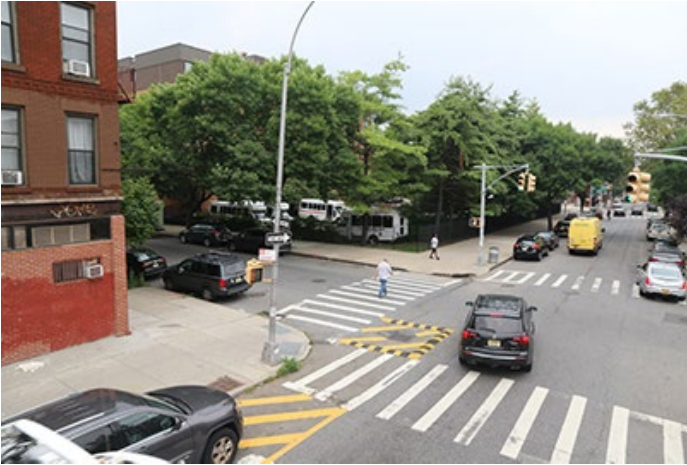
Figure 6: Example of hardened turning treatment ([NYCDOT](#))

- **Observation:** At Grove and Pecan Streets, vehicle speeds were high for those turning left from Belknap onto Grove or Pecan. **Recommendation:** Consider hardened centerlines to slow vehicles turning left onto Pecan and Grove Streets, and possibly other locations. Hardening refers to the use of modular curbs, vertical delineators, and/or striping at intersections to reduce left-turning speeds and to prevent “corner cutting.” Timeline: Short-term.

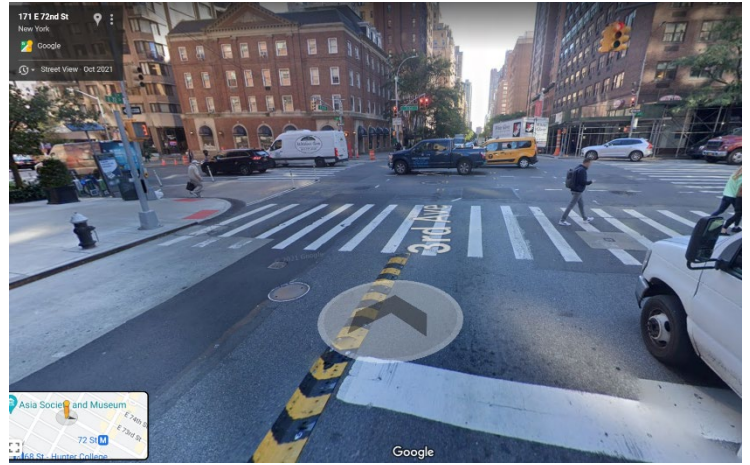
Figure 7: Example of hardened turning treatment ([Google Street View](#))

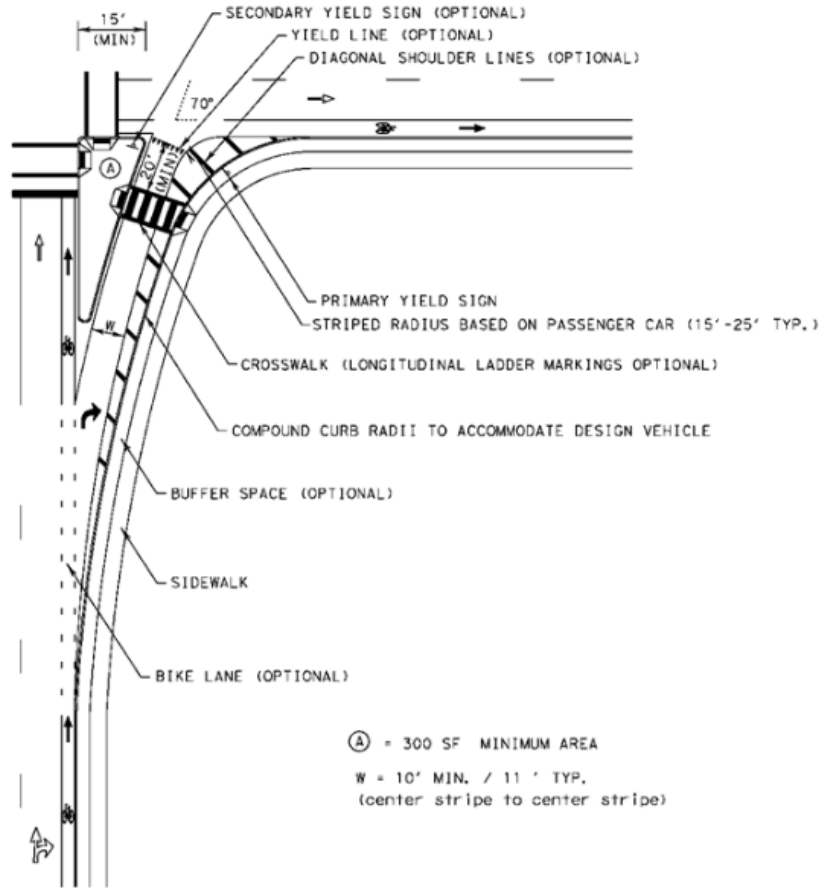
Figure 26: Right turn slip lane design (TxDOT)
